## DUCK POND DAM

NDI ID NO. PA-00379  
DER ID NO. 35-98

### PHASE I INSPECTION REPORT NATIONAL DAM INSPECTION PROGRAM

June 1981

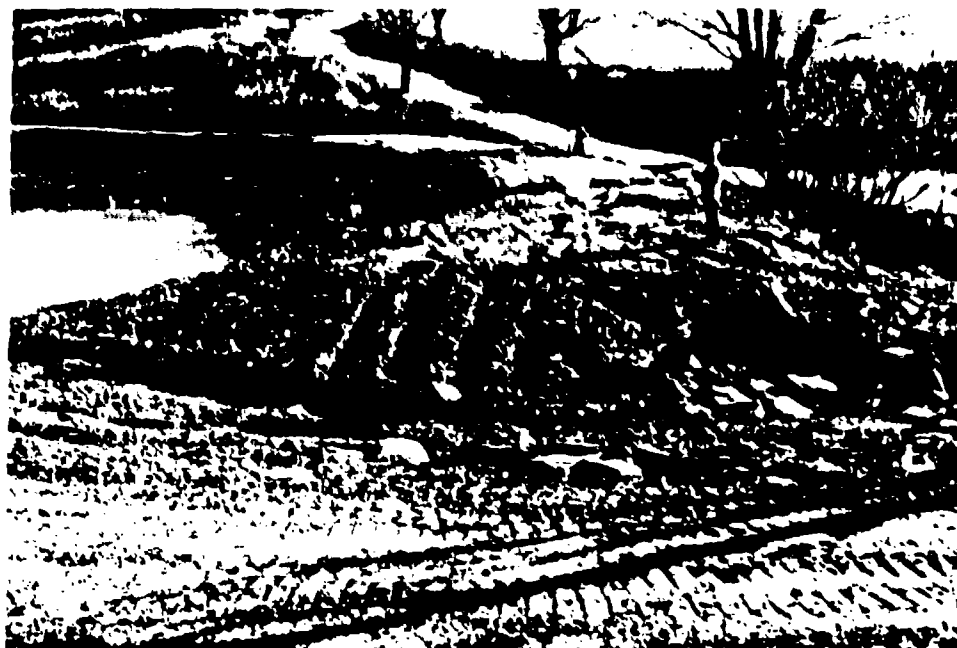
1. Crest and upstream face. Spillway  
in foreground (5 Nov 80).

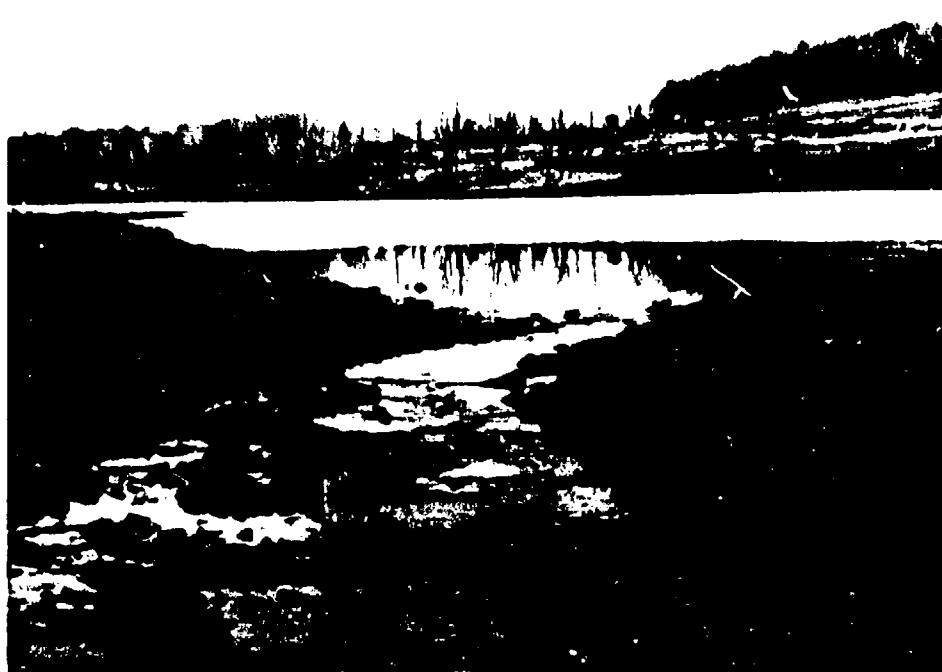
7. Southway approach and entrance.

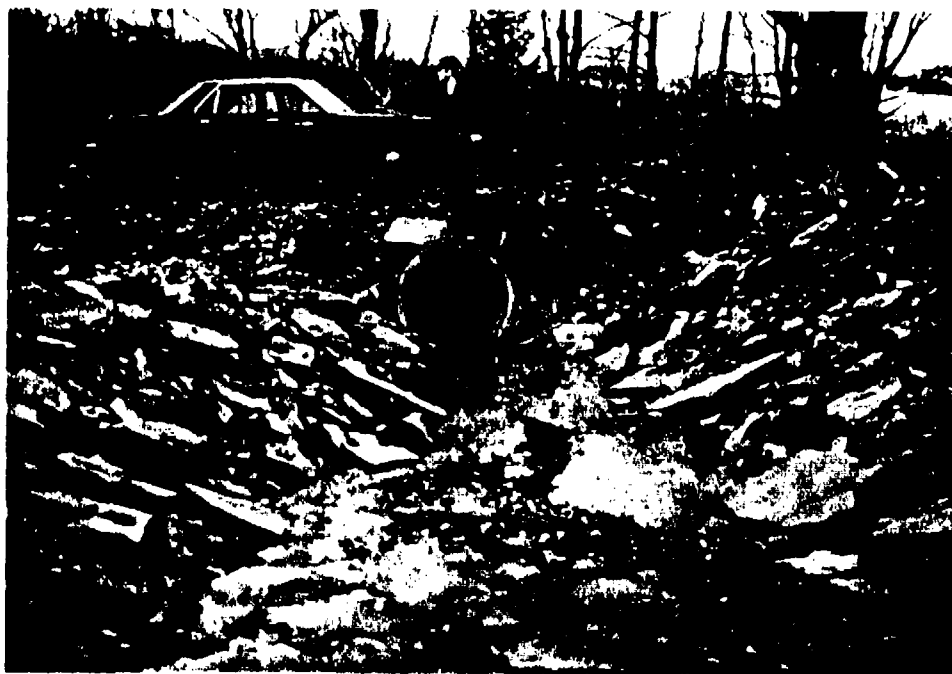
8. 16 inch diameter concrete pipe at end of riprap channel. Note irregular riprap.
